Appendix A – Aircraft Fueling

Evaluation of Existing Fuel Storage Facility

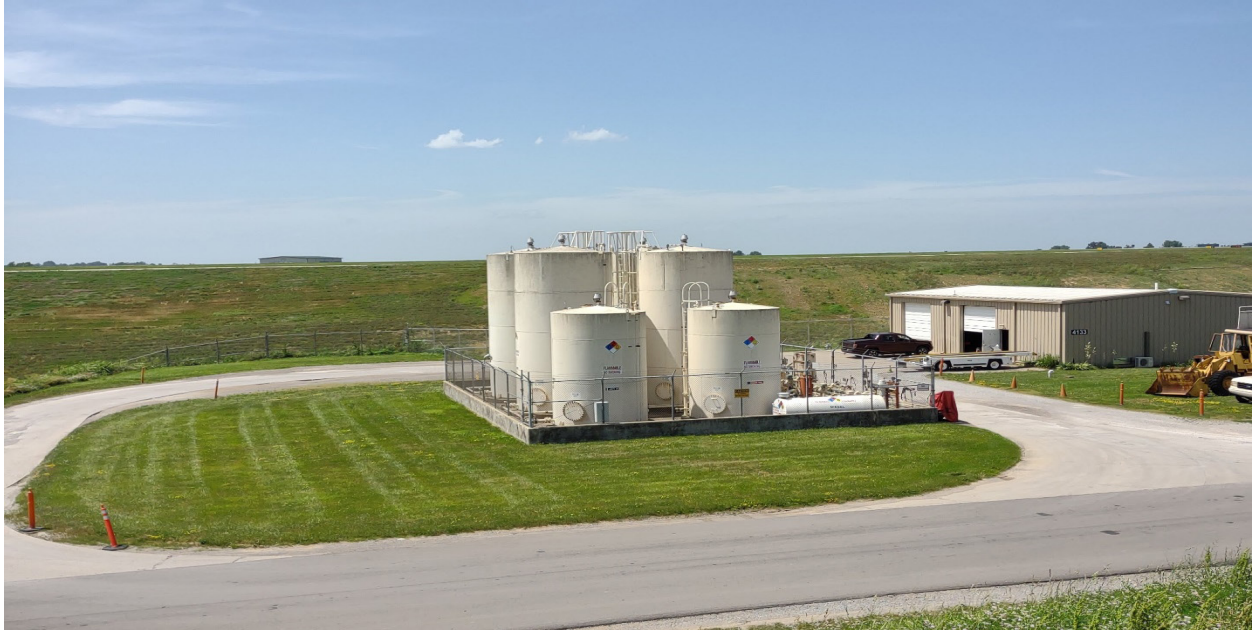
Figure A-3
Signature Flight Support Facility

All vertical tanks are single-wall, designed to UL 142 and NFPA 30. Tank spacing is slightly non-uniform with shell-to-shell dimensions ranging from 61 to 68 inches, but it is within the NFPA requirement of one-half tank diameter. All vertical tanks are equipped with the following appurtenances.

The tanks are situated within a concrete dike containment area measuring 55-feet by 45-feet by 3-feet high and have sufficient volume to contain a spill from the largest tank.

All tanks located at the Signature Flight Support facility exhibit failing coatings and visible corrosion. Except for diesel Tank A33, all tanks were last inspected on October 1, 2011. Inspections were performed to STI SP001 by Tetra Tech. All tanks currently appear to have the same issues indicated in the October 1, 2011 inspection reports. Listed deficiencies included failing coatings, visible corrosion, loose anchor bolts, and cracks in the containment dike. While cracks in the containment walls appear to have been addressed, corrosion and failing coatings have not been addressed.

To complete the recommendations from the October 1, 2011, inspection reports, it will be necessary to remove each tank from service (one at a time) to undergo media blasting and recoating as needed. Media blasting will require encapsulation of the tanks to prevent blast and paint from contaminating or damaging the surroundings and to maintain required environmental conditions, temperature, and humidity during coating. This process would leave one tank out of service for a period of six to eight weeks, thus reducing the facilities' storage capacity to 62,000-gal. At a capacity of 62,000-gal, the Signature Flight Support fuel facility would barely be able to maintain a 24,000-gal per day tank rotation, and fuel deliveries would need to be scheduled as soon as a tank is empty. The facility would not be able to supply fuel for more than one day at 40,000-gal per day. Refer to **Figure A-4** and **Figure A-5**.

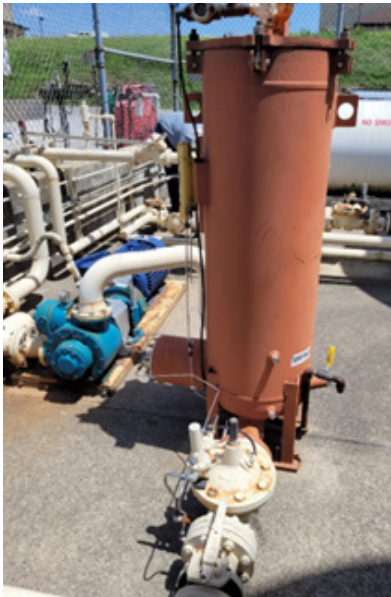
Figure A-10
Jet-A Loading and
Offloading System

The condition of the existing Avgas and Jet-A loading/offloading systems is similar to that of the tanks. The coatings are failing, and corrosion is visible. Basket strainers are located near the containment floor in a horizontal orientation, which does not allow complete draining through the bottom drain when servicing the strainer, increasing the likelihood of minor spills.

- ✈ Two Jet-A loading and offloading assemblies, each consisting of:
 - One 15 HP/150 gpm Blackmer positive displacement pump
 - One 270 gpm Facet filter separator with 4-inch check valve and 4-inch control valve
 - One 4-inch basket strainer
 - Necessary valving
 - One 4-inch analog meter with 4-inch control valve
- ✈ One Avgas loading and offloading assembly consisting of:
 - One 15 HP/150 gpm Blackmer positive displacement pump
 - One Avgas filter
 - One 4-inch basket strainer
 - Necessary valving
 - One 4-inch analog meter with 4-inch control valve

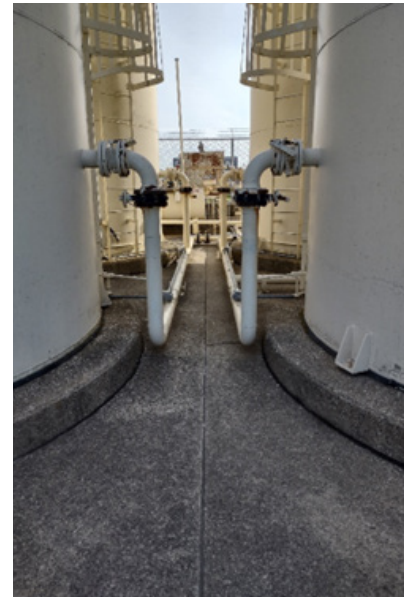
Figure A-12
Tank Facility
Piping

In general, the Signature Flight Support fuel storage facility equipment and piping are in poor condition and near the end of their useful life. Coatings are failing and corrosion is prevalent. It was noted that some meters are not accurate and are not used for inventory purposes. Two new filter separator units are in good condition. The valves, flanges, nuts, bolts, and studs throughout the facility exhibit corrosion. In addition, the electrical components of the system show deterioration and may present unsatisfactory protection against the hazardous classification.

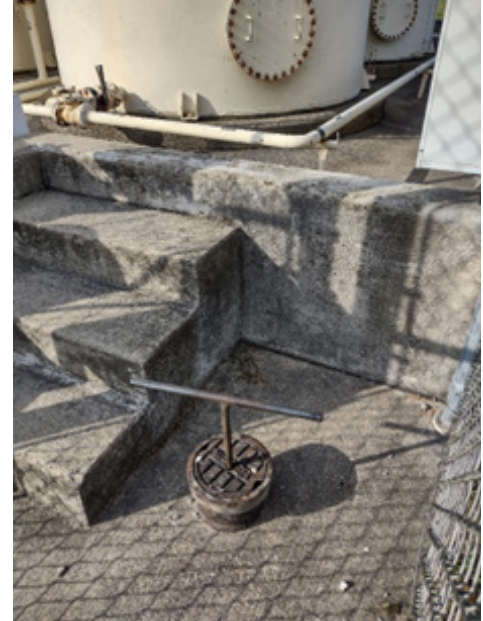
Figure A-13
Dike Area Drain Valve

The diked area is equipped with a catch basin and a normally closed isolation valve leading to an oil/water separator. Based on dialogue with the facility operator, the oil/water separator is functioning properly; however, this could not be verified. There is one catch basin tied to an oil/water separator piping for loading and offloading operations of refuelers and tanker trucks, with no apparent spill containment curbing or rollover.

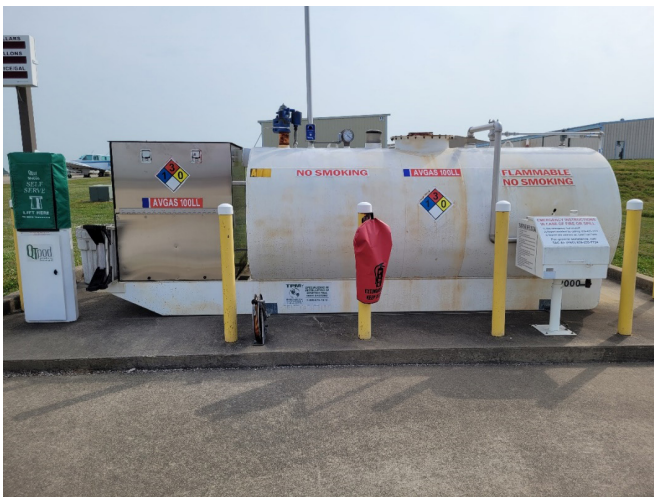
Figure A-15
Tank A79

The Airport maintains two skid-mounted Avgas tanks (A79 and A83) located in separate general aviation areas, including the East area and the West area. Both tanks are double-wall UL 142 packaged units equipped with cabinets that include a filter, meter, hose reel, grounding reel, fill connection with spill box, control valves, and valves arranged to facilitate issue operations. Both Avgas tanks are equipped with self-serve kiosks.

Both Tank A79 and A83 are in good condition, with all equipment in good working order. Tank coating is intact with some discoloration from corrosion on manway bolts and other tank connections.

- ✈ Tank-mounted appurtenances include:
 - Tank-mounted pump
 - 2-inch atmospheric vent
 - 2-inch manual gauge hatch
 - 2-inch dial gauge with level alarm
 - 6-inch interstitial emergency vent
 - 24-inch manway
 - 8-inch emergency vent
 - 4-inch fill connection to 2-inch fill line
 - 2-inch thermal relief return with 1-in return line
 - 2-in interstitial level gauge
 - 2-inch sump with 1.5-inch line to manual pump

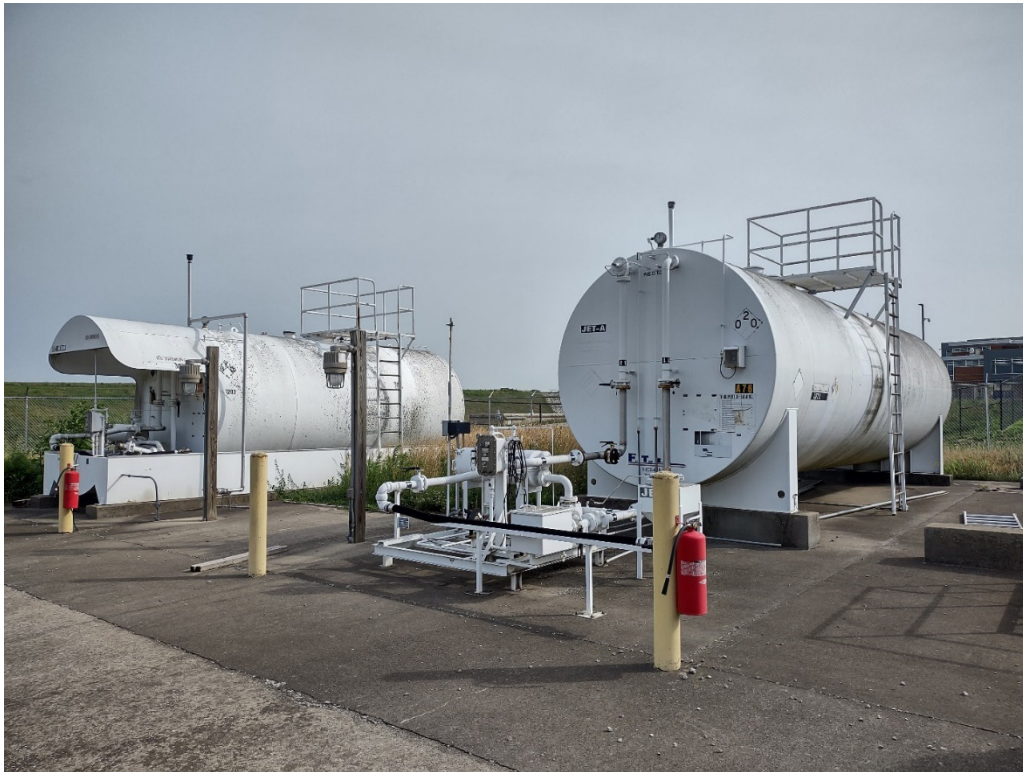
Figure A-17
Abandoned Fuel Facility

Aside from the Signature Flight Support facilities, the Airport owns an abandoned fuel facility located immediately north of the Signature Flight Support facility. The facility consists of a 20,000-gal Jet-A system, 15,000-gal packaged Avgas system and a small 200-gal diesel fuel tank. These may be sold for metal recycling or purchased for reuse by others. If the Airport desires to put these tanks back in service, the tanks will require inspection, STI SP001, before determining suitability for service. All other components (i.e., electrical and mechanical) will require testing, refurbishment, or replacement if necessary.
